## SHOFFNER CONSULTING

RE: Tree Inventory - 2320 W. Emerson St. Seattle, WA.

#### 1. Site Conditions

# 2. Tree Inventory, Condition Assessments and Exceptional Status

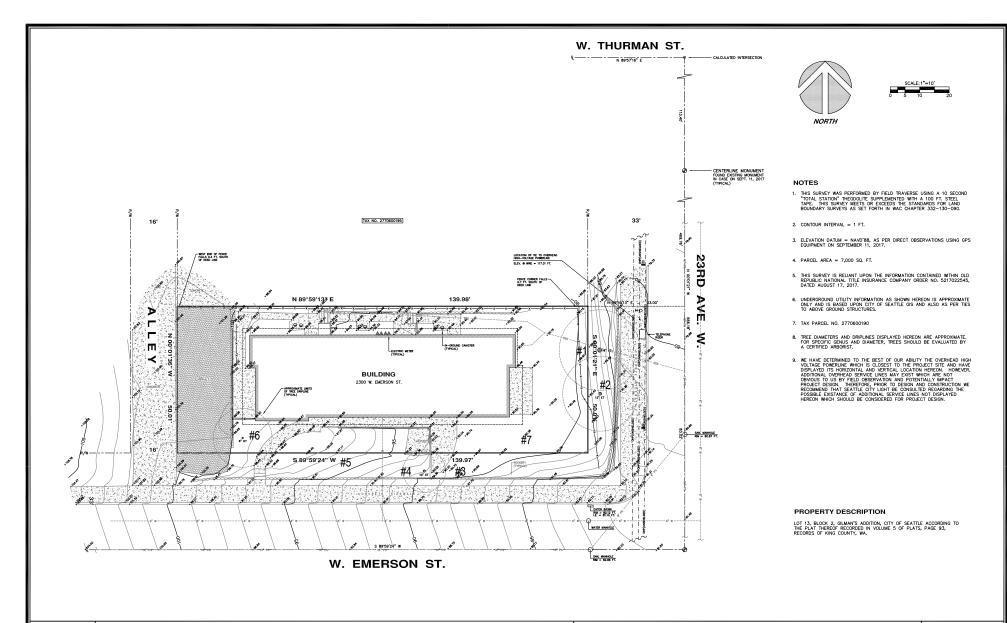
TOPOGRAPHIC SURVEY
2300 W. EMERSON ST.
SEATTLE, WASHINGTON

- 1. Blue colorado spruce (*Picea pungens 'glauca'*), 18" dbh, 24' crown spread. Good condition and health. Not exceptional.
- 2. Blue colorado spruce, 18" dbh, 24' crown spread. Good condition and health. Not exceptional.
- 3. Noble fir (*Abies procera*), 5", 8' crown spread. Fair condition and health. Not exceptional.

- 4. Noble fir, 14" dbh, 12' crown spread. Poor condition, multiple tops. Not exceptional.
- 5. Japanese maple (*Acer japonicum*), 4" dbh, 10' crown spread. Good condition and health. Not exceptional.
- 6. Japanese maple, multiple trunks (2, 2, 2, 3, 4) 6.5" dbh, 18' crown spread. Good condition and health. Not exceptional.
- 7. Apple (*Malus domestica*), 5" dbh, 12' crown spread. Good condition and health. Not exceptional.

None of the trees are exceptional, therefore, no retention is required and if any trees are retained, no protection is required.
