August 6th, 2018

APPEAL ATTACHMENT 'J1'

RE: Tree Inventory - 3424/3416/3410 23rd Ave. W. Seattle, WA.

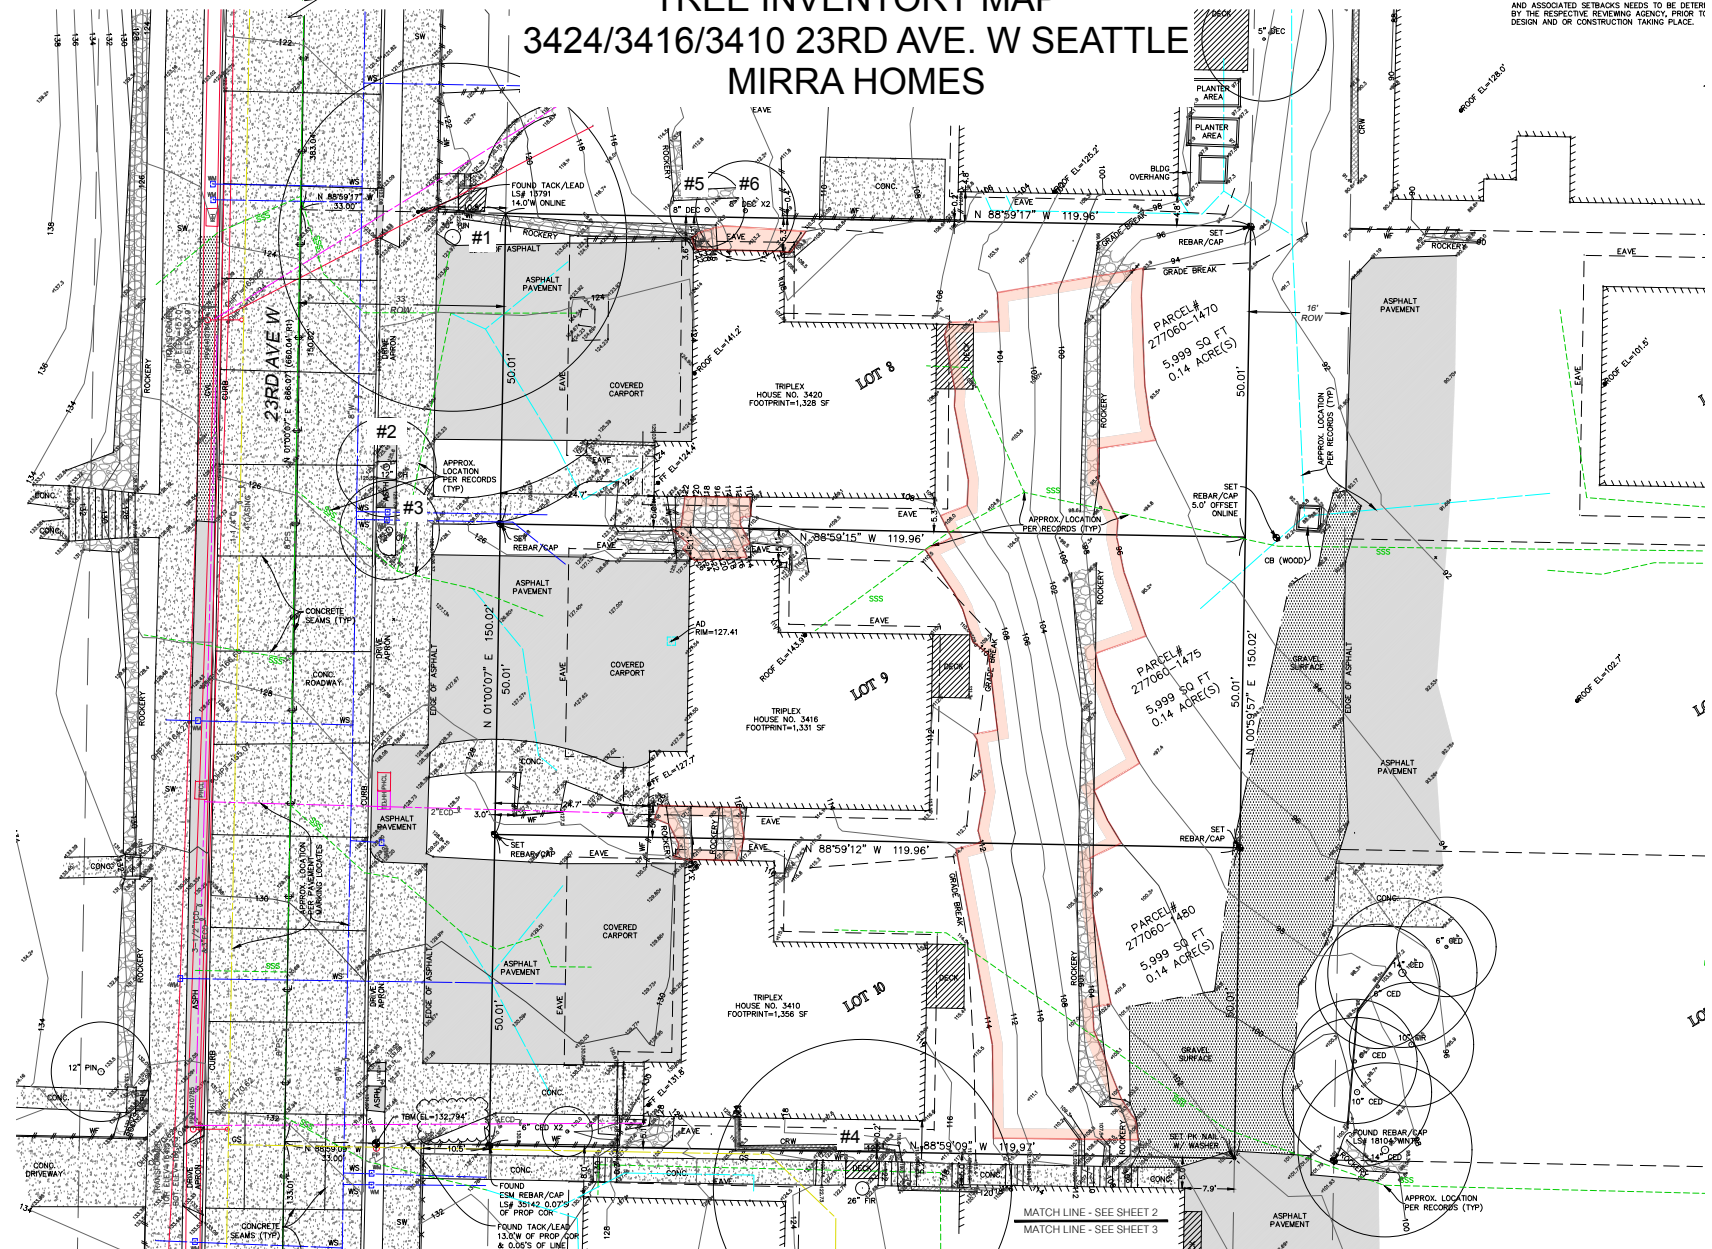
#	Species	Dbh	CSD	Condition and Status
1	Scot's Pine (<i>Pinus sylvestris</i>)	38"	35'	Good condition and health. Within right-of-way. Exceptional. To be retained and protected.
2	Cherry (<i>Prunus serrulata</i>)	8"	0'	Fair condition and health. Not exceptional.
3	Cherry (<i>Prunus serrulata</i>)	8"	0'	Fair condition and health. Not exceptional.
4	Douglas fir (<i>P. menziesii</i>)	26"	8'	Good condition and health. Not exceptional.
5	Western red cedar	8"	12'	Good condition and health. Not exceptional.

Being within the right-of-way, the standard exceptional tree protection measures may not apply for tree #1, however, SDOT will require a degree of protection for this tree.

Retained exceptional trees are required to be protected through construction. There are two protection zones for exceptional trees in Seattle. The inner root zone (IRZ) is the inner half of the dripline radius and no impacts are allowed within this zone. The outer root zone (ORZ) is the outer half of the dripline radius and no more than 1/3 of the total area of the ORZ is allowed to be impacted. Any impacts proposed within the ORZ will need to be assessed prior to beginning work in order to determine the affect of the proposed impacts upon the tree(s). Protection fencing will be required with City of Seattle signage stating the protection measures and no encroachment specifications.
