Arborist Report

SITE: Talaris Campus, 4000 NE 41st Street, Seattle, WA 98105

RE: Tree Inventory and Assessment – MUP Submittal

DATE: August 6, 2019

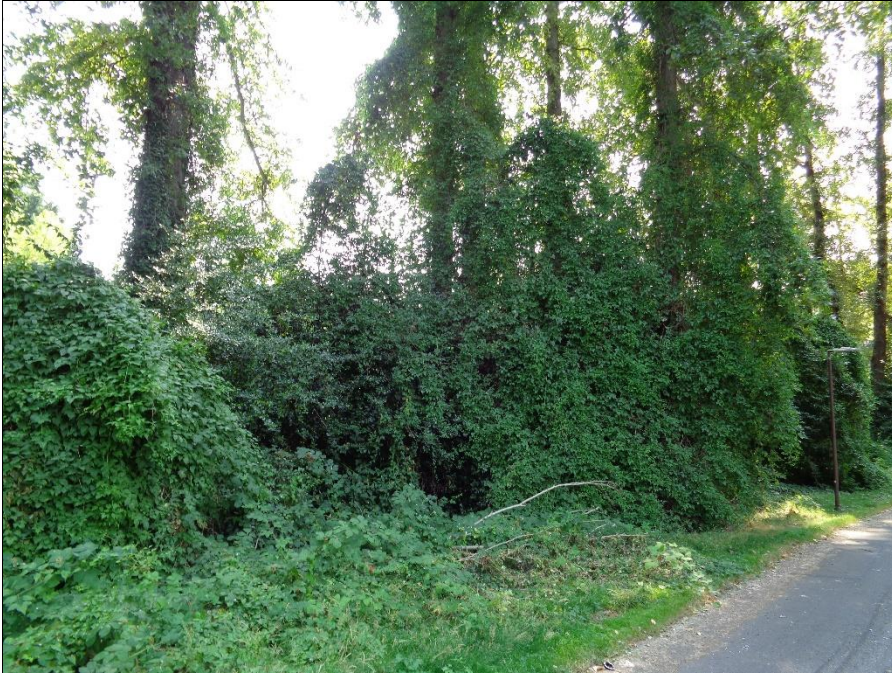
Photo 1. There are several invasive plant species growing on site, including invasive ivy, especially toward the wetland and perimeter of the property.

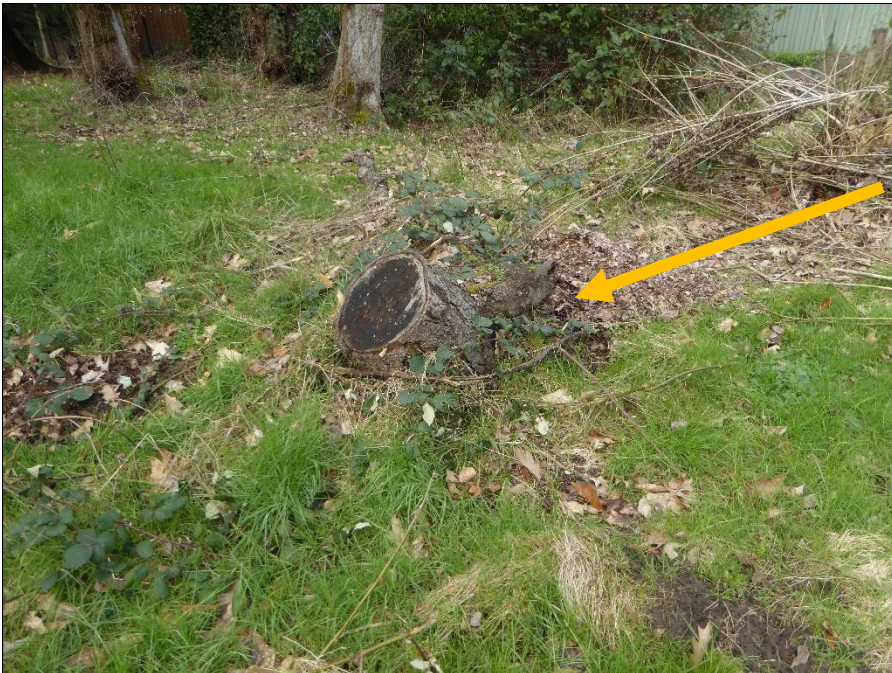
Tree numbers referenced in this report are from an original survey and inventory that was completed several years ago. Since the original inventory, many trees have died or were removed (Photo 2) and therefore tree numbers are not sequential. Trees that were not found on the survey were tagged starting at 980. Approximate locations of all lettered (offsite) trees and trees numbered greater than 980 were added to the site map. These trees should be surveyed and located accurately on the site plans.

Photo 2. An example of a tree that failed and has been removed since the original inventory.

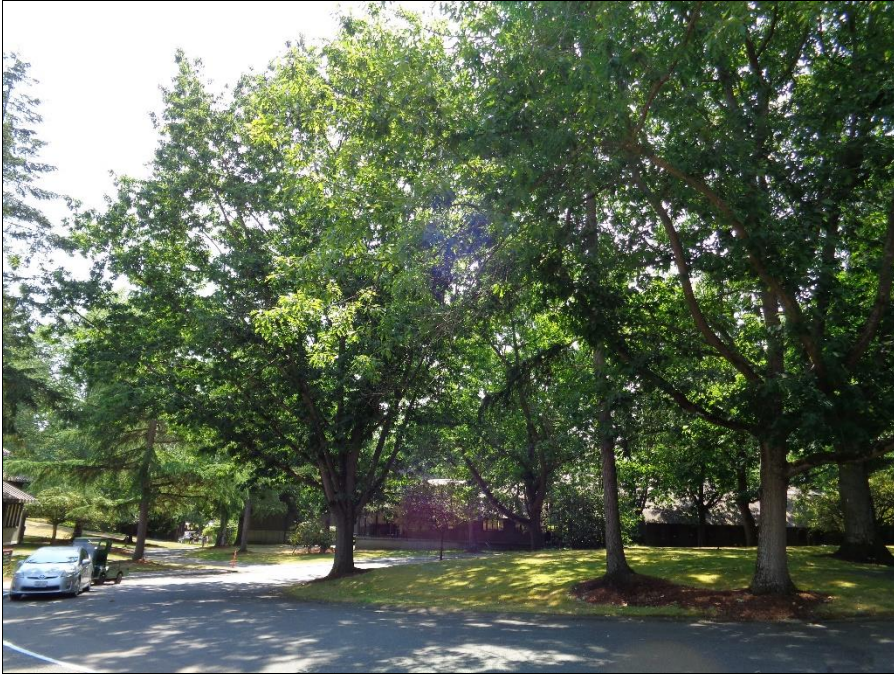
Photo 3. A portion of the oak grove north of buildings D.

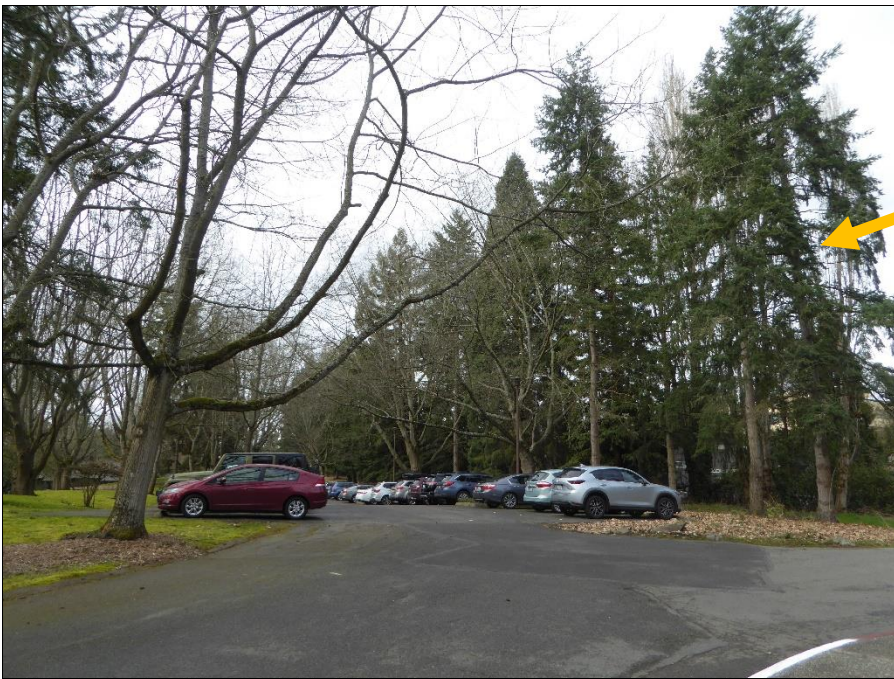
Photo 4. Conifer trees growing in the grove along the north property boundary.

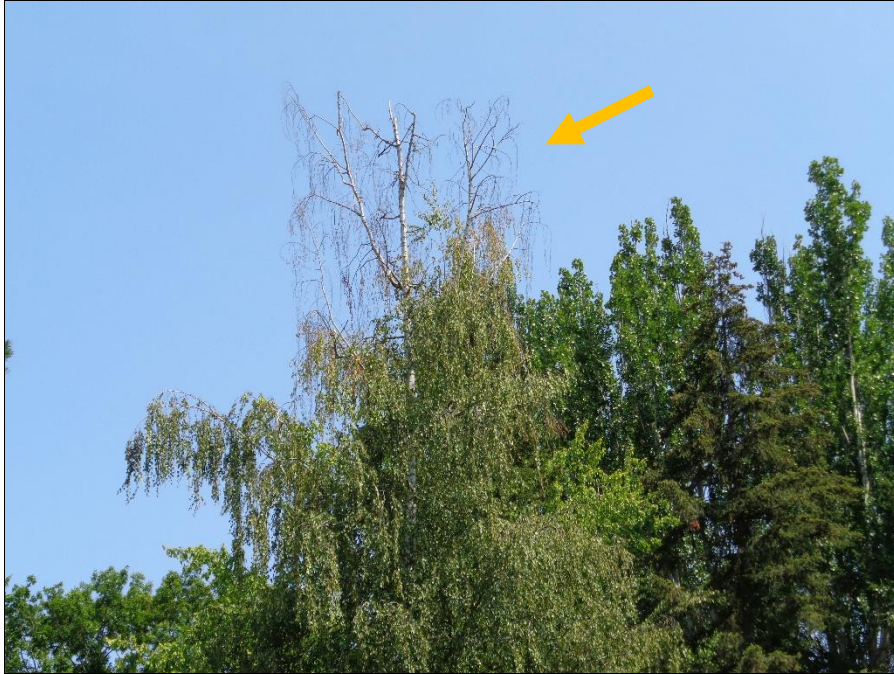
There are seven European white birch trees growing on site. All but one of these trees are showing symptoms of infestation by bronze birch borer (Photo 5). This pest is very difficult to manage without the use of insecticides that have off-target impacts on beneficial insect and birds. It is likely that these trees will die of this infestation over the next five years or so. We do not recommend treating the birches to preserve them.

Photo 5. The top of a birch tree that has died and has started to break apart. This is a symptom of bronze birch borer.

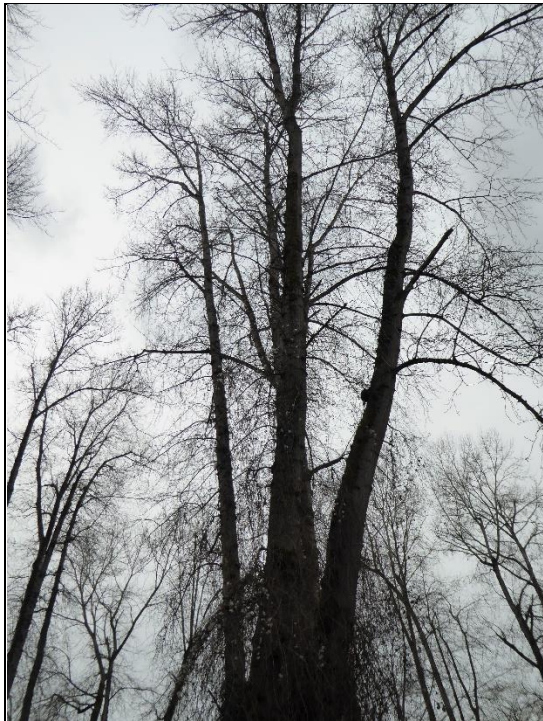
Several of the cottonwood trees, especially those growing in the wetland area toward the southwest corner of the property, are in mature form with large canopies, branch tear outs, and stem decay (Photo 6 and 7). The trees do not currently present a high-risk level due to the lack of surrounding targets. We recommend that a careful management plan be produced to address potential risk issues to new targets developed within striking distance of these trees. Some of the trees along the interior roads and along NE 41st Street have been managed in the past to reduce the risk of branch failure onto the roads. This work was specified by Tree Solutions.

Photo 6. An example of the canopy condition of many of the cottonwood trees growing on site. These trees have massive canopies with large scaffold branches and a history of broken limbs and tear outs.

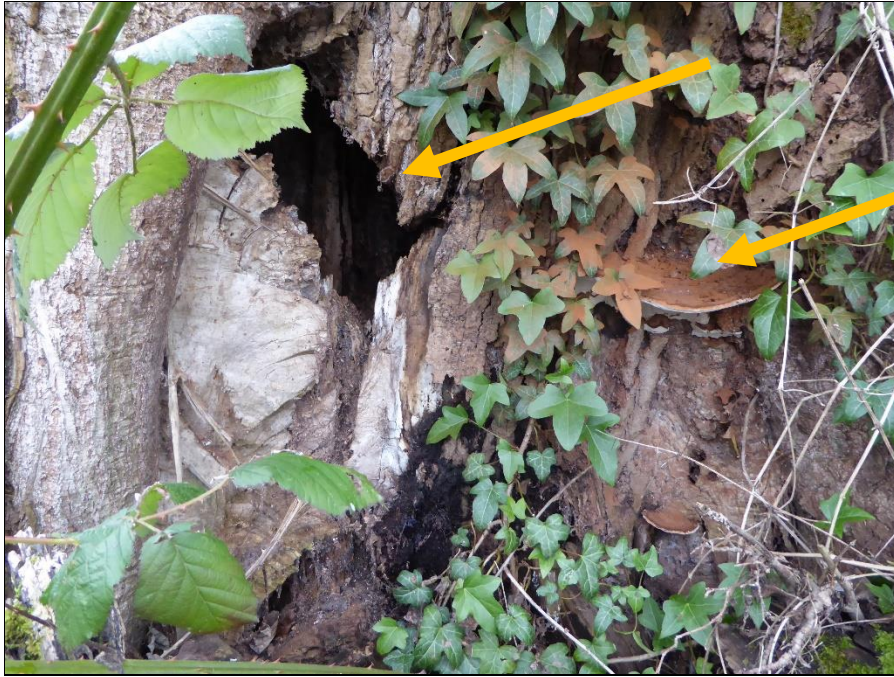
Photo 7. An example of a cottonwood with basal stem decay and decay fungus growing on the trunk.

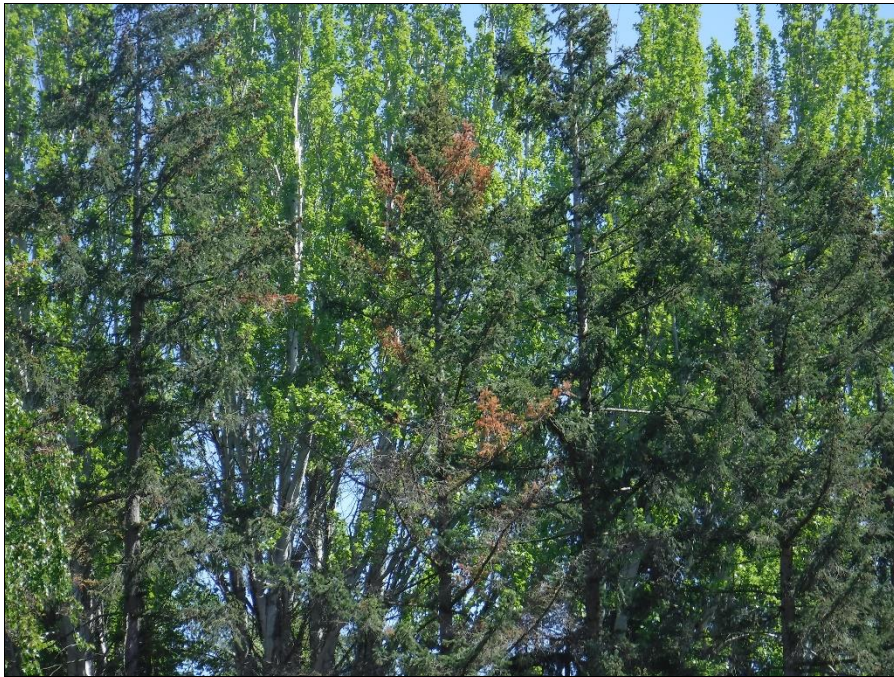
Photo 8. An example of a Douglas-fir growing east of the motel showing early symptoms of decline.

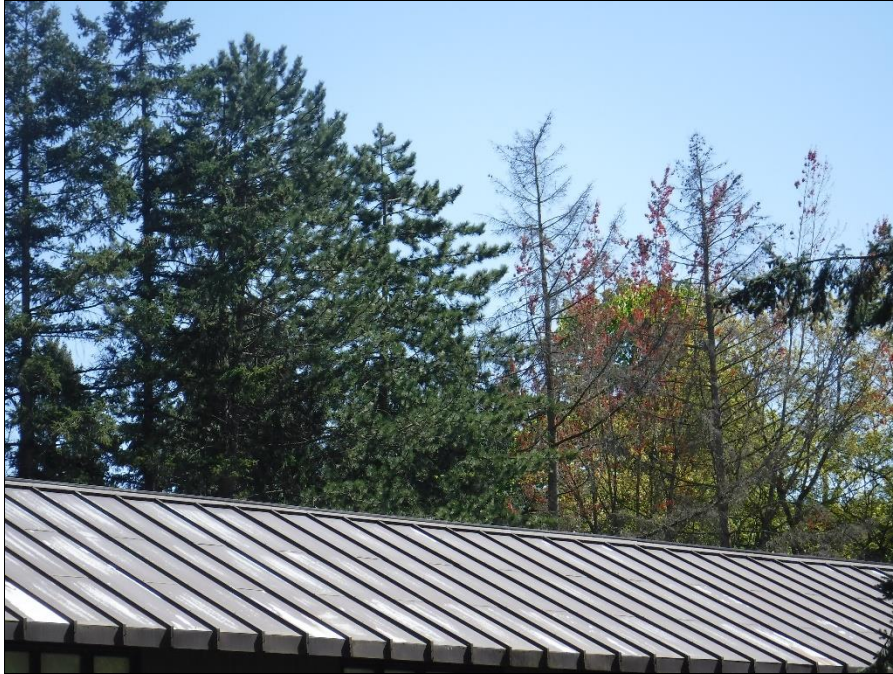
Photo 9. Two trees in the same row as the Douglas-fir in photo 7 that have declined and died since the original inventory.
