Arborist Report Correction Notice #1

RE: 2925 E Madison St
Correction Notice #1 Response

Response to City Corrections Notice #1

TO: Geza DeGall, The Velmeir Companies
SITE: 2925 E Madison St, Seattle, WA 98112
RE: Project# 3020338
DATE: September 15, 2016
PROJECT ARBORISTS: Sean Dugan, ASCA Registered Consulting Arborist #457
ISA Board Certified Master Arborist #PN-5459B
ISA Qualified Tree Risk Assessor

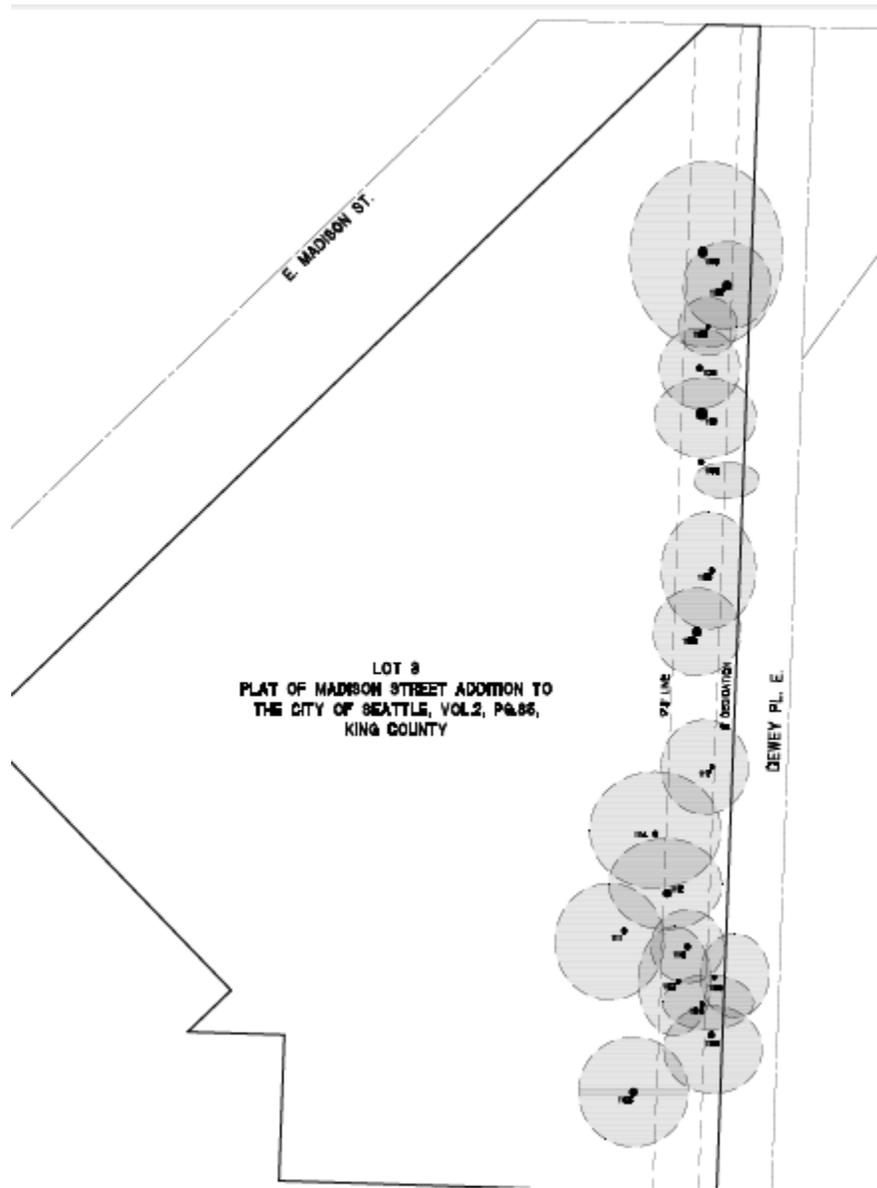
Appendix A – Trees located on current tree Survey

All trees less than 12 inches in diameter have been removed from the Eastern Tree Exhibit. The Exhibit shows the location of and canopy dimensions of all trees 12 inches in diameter and greater. The five foot setback line depicts the location of the required dedication. The slope stabilizing retaining wall will at minimum be placed two to three feet west of this dedication. The 17.5 foot setback line shows a maximum setback line for the face of the building and illustrates the challenges in retaining trees on the slope given the building envelope, required ROW dedication, and retaining wall location.

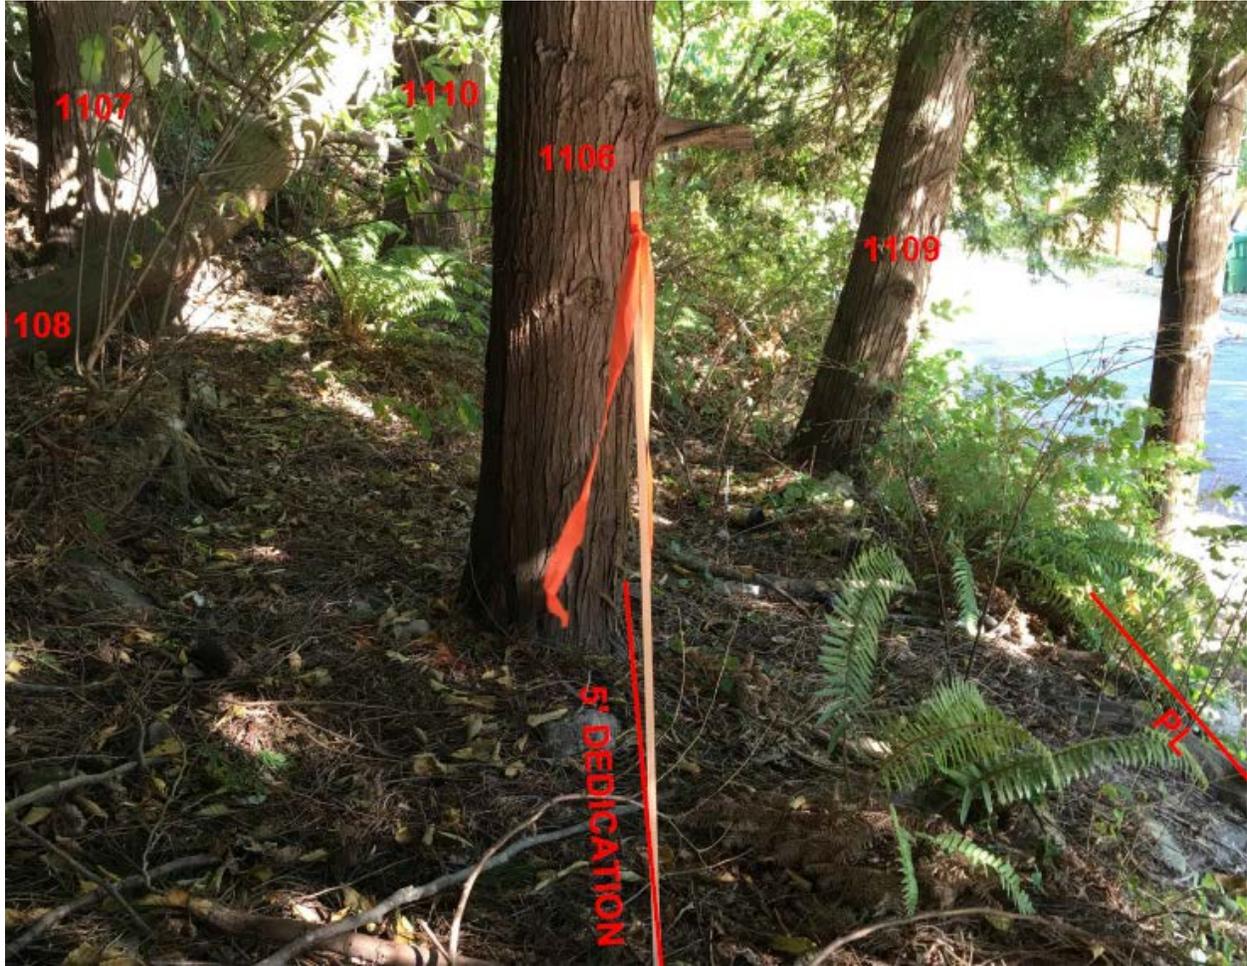
Photograph 1. View looking to the north. The dedication and proposed retaining wall will at minimum result in the removal of trees 1106, 1109, and 1110.

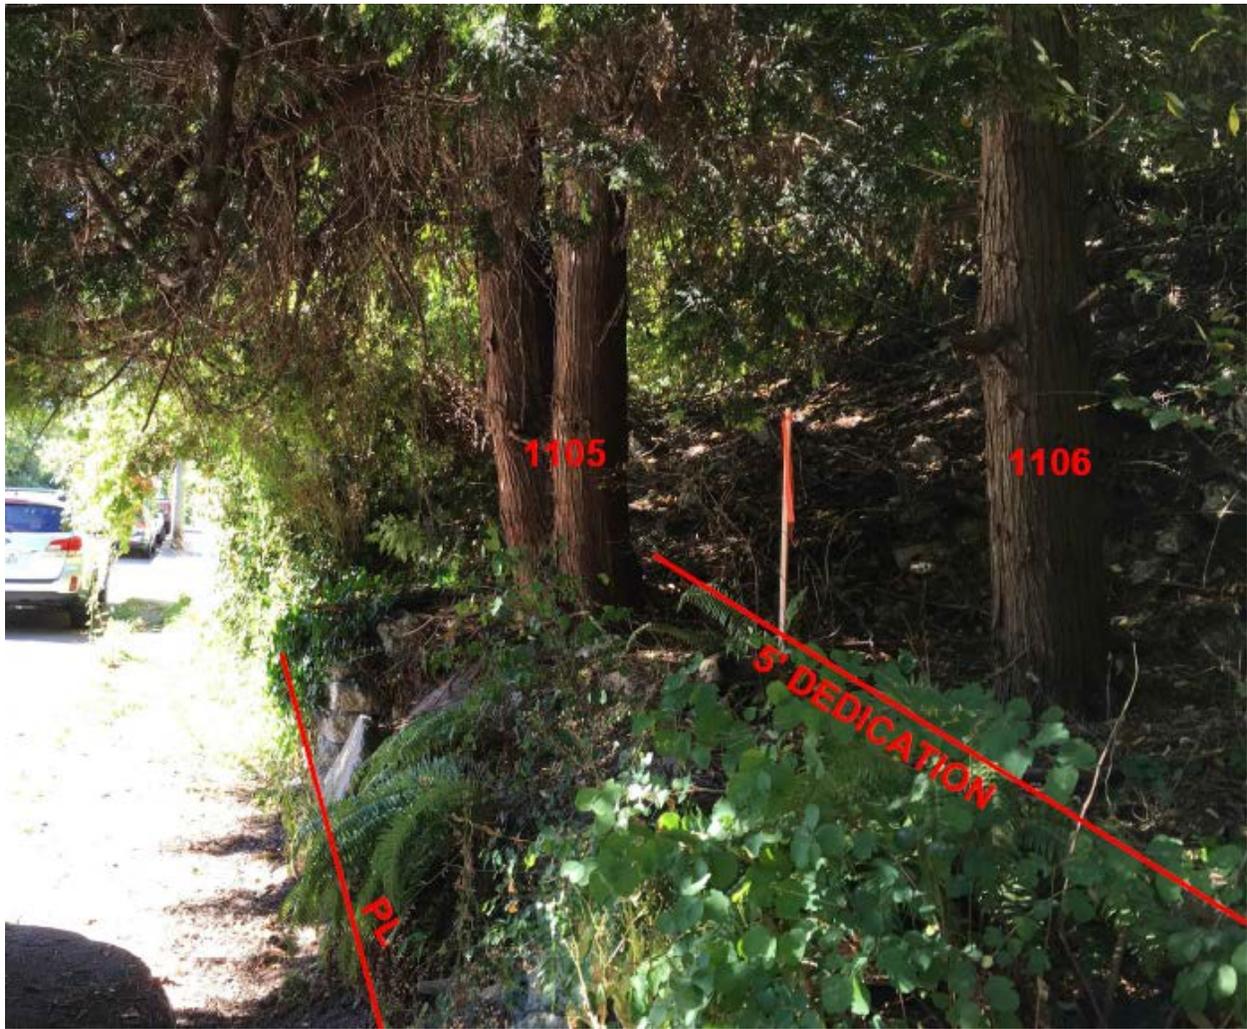
Photograph 2. View looking to the south. Trees 1105 and 1106 will be compromised by the necessary safety retaining wall.

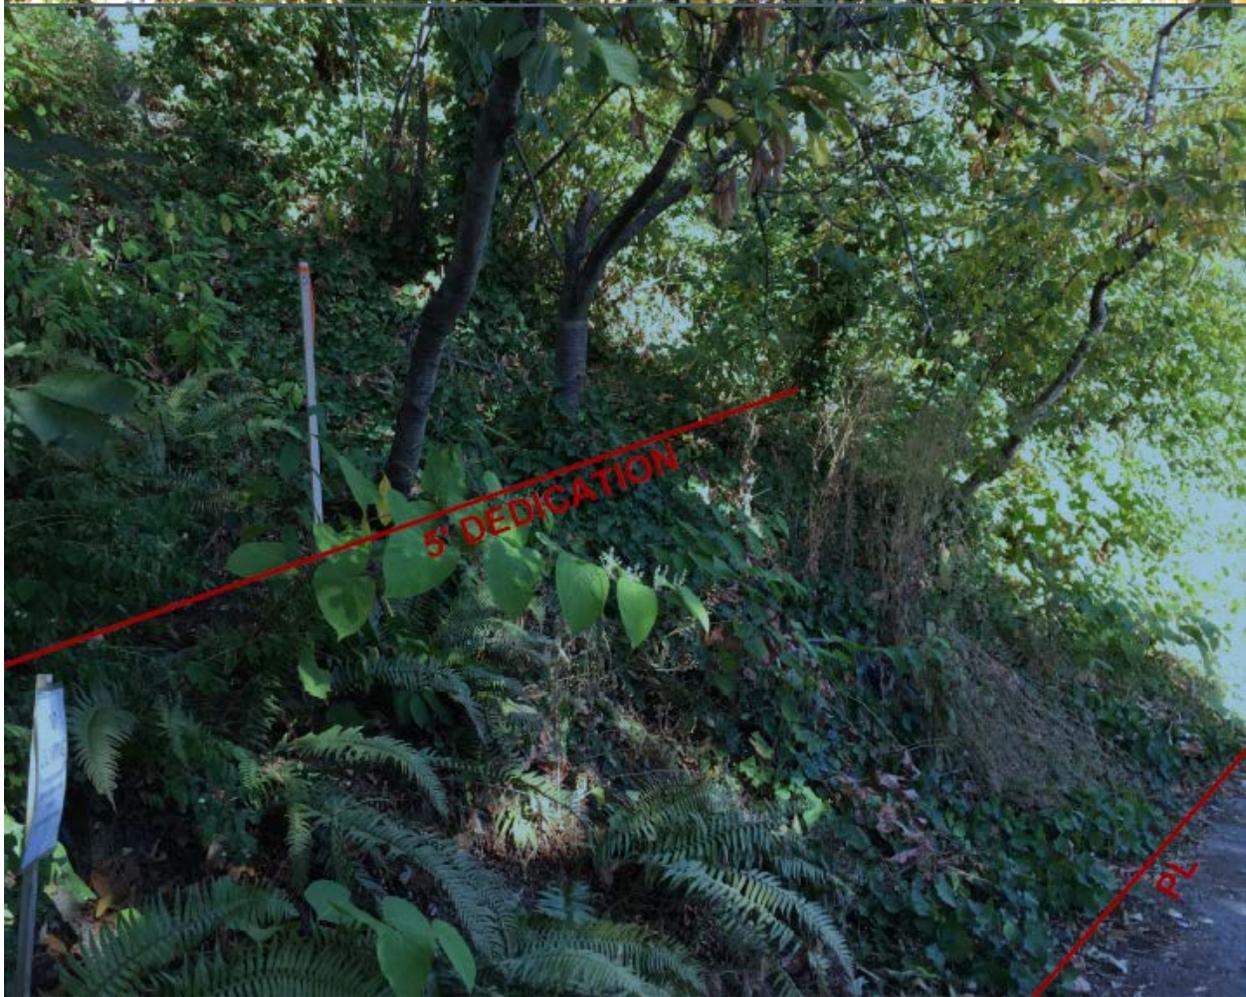
Photograph 3. View looking to the north. Many of the trees near the minimum ROW location and west of the proposed safety retaining wall will be negatively compromised by the site development.
